Chesterton Engineered Solution Working for 12 Years Without Failure

Pulp & Paper | Paper Stock | Mechanical Seal

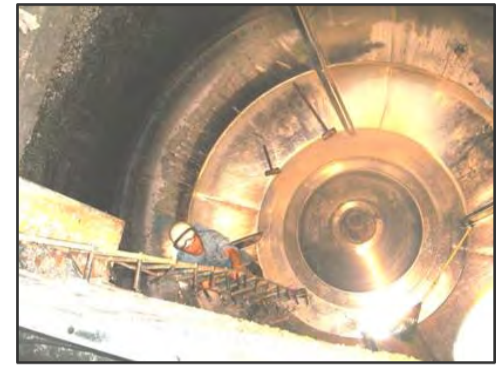
Large DIP Pulper, top view

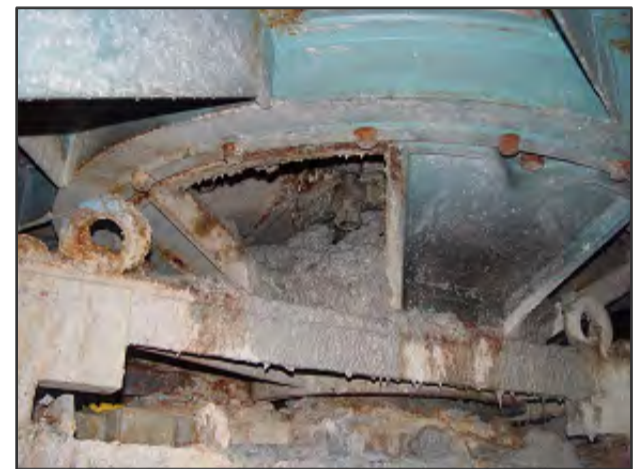
Customer has issues with frequent repacks (every 3 months). Leakage into gearbox and bearings causing oil contamination and poor reliability.

Before, damaged gearbox with leaked product

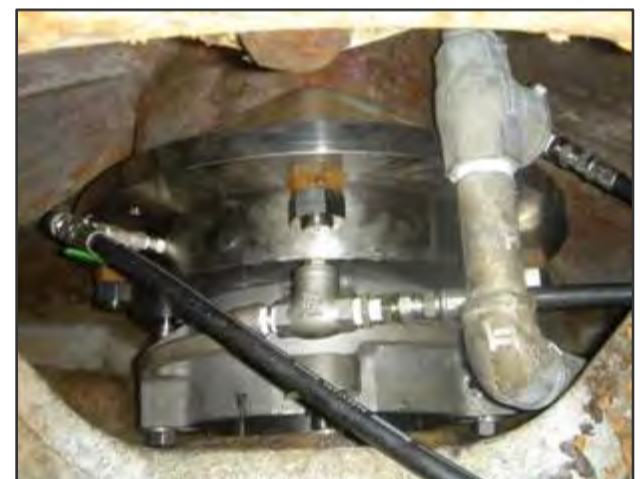
Installed Chesterton Engineered Solution

- Chesterton 221 220mm RSC/CB FKM jumbo seal
- Chesterton 14K 220 mm Restrictor Bushing
- **Split, 2 piece Packing Version SpiralTrac** made of carbon-graphite PTFE (ESC) material, part# *PM37000RS42000(ESC)26433*

SpiralTrac was installed over an MC Nylon Bushing. This solution was installed in November 2006.

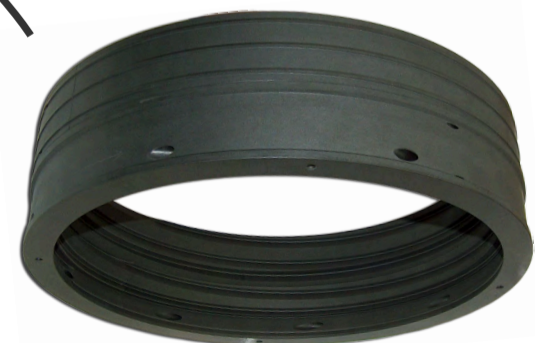
2 piece Packing Version SpiralTrac
